Rehabilitation Status by Robert Ashton

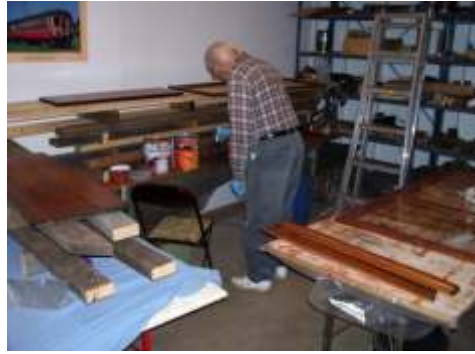
Stewart Walker staining and lacquering

The bulkhead doors and bulkhead walls, except for the middle bulkhead, have been stripped, re-stained, lacquered and equipped with new window safety glass.

The interior wood is now being stripped of old lacquer before it can be re-stained and re-lacquered.

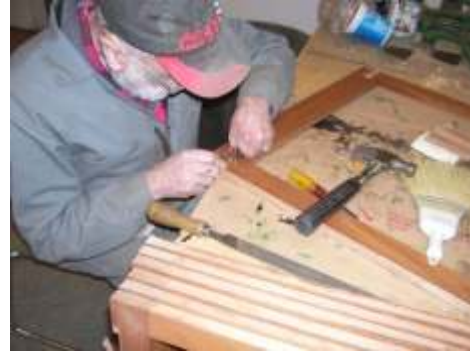
Rene Doyharcabal, brass window fittings

All the rebuilt upper windows have been placed back into position on both sides of the car. For the lower windows, all the brass fittings have been put onto the sashes. The mouldings that go on the sides of the uprights and allow the windows to stay open, are about 90% completed. Some of the wood will be original and some of it will be new, depending on the water damage that has occurred. The new ratchets that the window latches attach to, to keep the window open, have had all their screw holes drilled and they are being put onto the mouldings.

All the brass that was required has been cast and donated by Hastings Brass. We owe them a huge thank-you! We're currently in the process of getting the rough casting coatings removed so we can send them to be polished, then treat them with a protective coating so they don't require constant polishing.

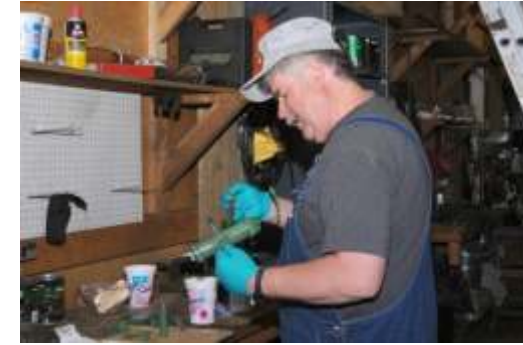
Neil Wilkie painting

In the interior, all the seat frames have now been disassembled, stripped, sandblasted and coated with a primer and about 90% have been put back together, and painted BC Electric Green.

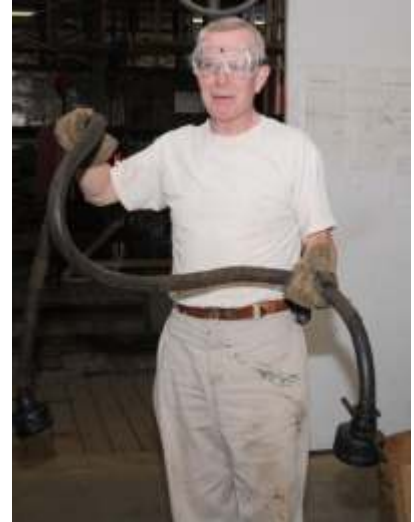
Ron Jones with Power Cable

Underneath the car, about two-thirds has been scraped clean and painted black. Upgrading and replacement of wiring under the car is still underway, about 80% of that work has been completed. Where we could save the original protective coating of the wire, we've done that.

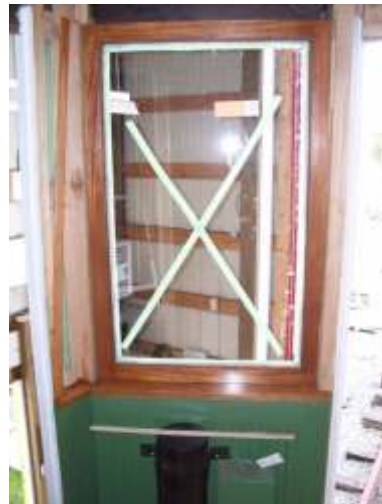
Left front window

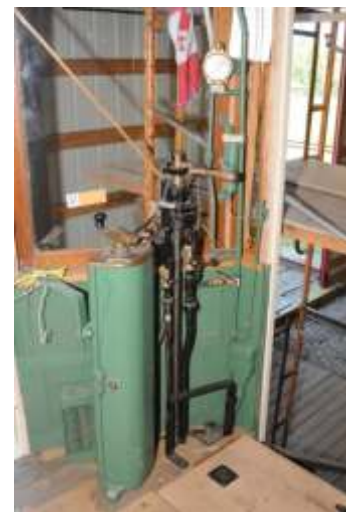
A end vestibule

The north end of the car, as it sits in the barn, that we call the "A" end, is about 99% complete. All the wood that we could save from the original (about 20%) has been put back. One trap door has been fabricated and put in place.

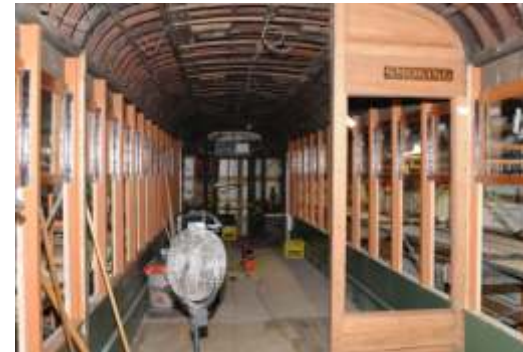
Long shot of the car with new woodwork

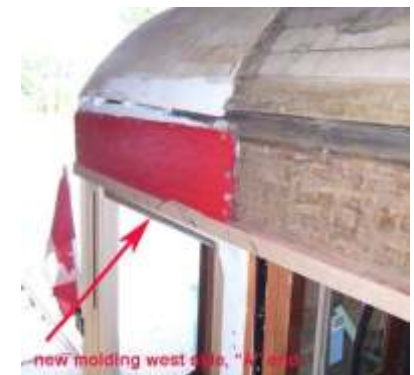
new molding west side

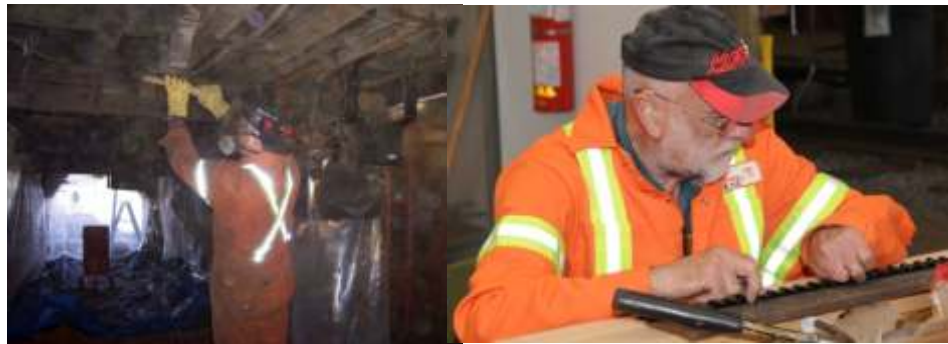
Scraping the underside of the car

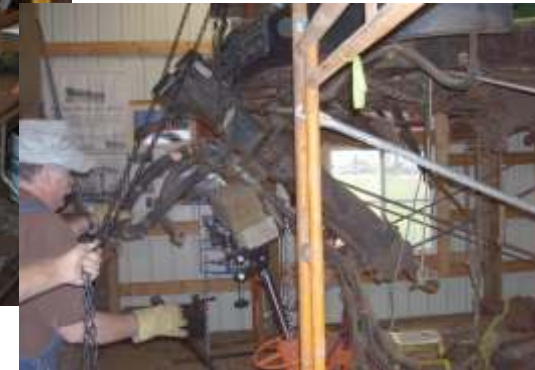
Neil Wilkie removing the B Coupler

The final set of old stairs has been removed, we are getting ready to remove the "B" end coupler and the Watson guards. This end of the car has to be completely taken apart and rebuilt, hopefully that will start by the end of August. That will be a major winter project and hopefully will be done by this time next year.

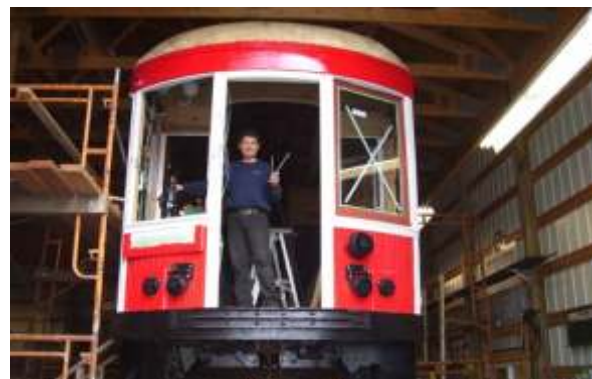
Ron Powers at the A end

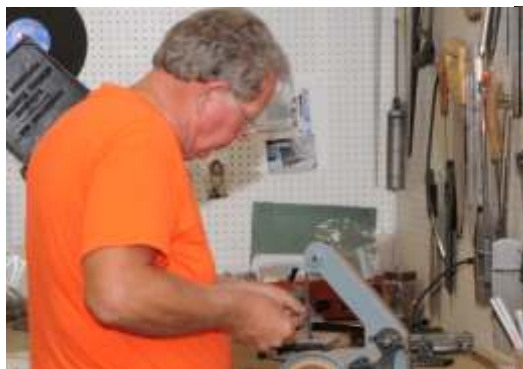
Ken Creasy sanding scroll work

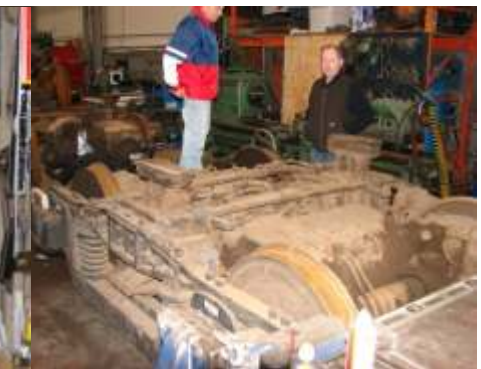
Truck at Carrs Machinery

The motors and the trucks have been taken out and are at Carrs Machining in Port Coquitlam and are currently being rehabilitated. Hopefully, by this time next year the work will be completed.
